# ORD Problem Solved!

## Ozone Attack

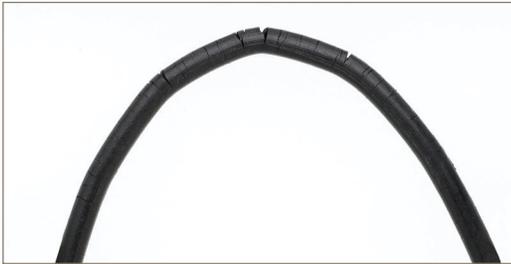
Ozone cracking is caused by an aggressive chemical attack on a double bonded seal polymer. Elastomers with double bonds in their molecular chains are highly susceptible to ozone attack. In their free state, the polymer remains unstressed, therefore the molecular interference prevents ozone from attacking the double-bonds. However, when the polymer chains are stretched, the molecular interference is disrupted, thereby exposing the double-bonds. Once this double-bond is exposed, it reacts with ozone and breaks at this point. This is then repeated for each progressively deeper layer of polymer chains within the rubber. On the surface, this shows up as cracking in the seal. This ozone cracking permits gases and fluids to pass through in an application.

The cracks that were forming on the surface of the NBR O-rings, when stretched over the tube fitting, are characteristic of a failure mode referred to as ozone attack. Ozone attack occurs when a NBR O-ring is stretched and exposed to ozone for a period of time, sometimes as short as a couple weeks. The ozone that is present in the earth's atmosphere is enough to break the polymer chains that make up the NBR compound, thereby forming surface cracks on the seal.

To prevent ozone attack, Parker proposed that the customer move to a compound that would provide ozone resistance while giving equivalent or better performance in CNG. Parker's KA183-85, a hydrogenated nitrile rubber (HNBR) compound, was recommended because of its ability to meet the low temperature requirement of the application. KA183-85 also provides excellent resistance to CNG and is ozone resistant.
